# Windham Town Hall

## Condition Assessment Report for the Town of Windham

Final January 31, 2022

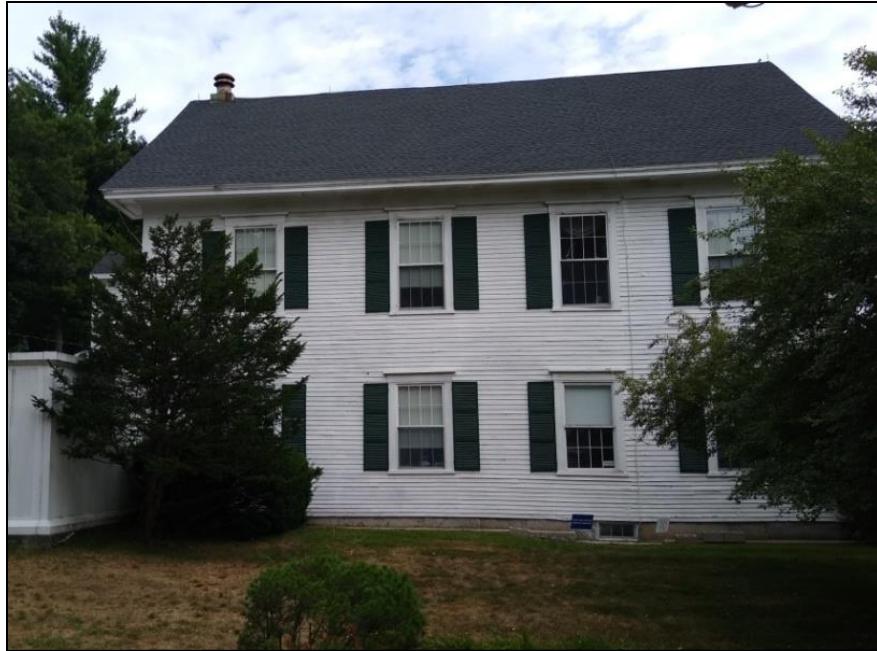
The site conditions around the Town Hall provide good drainage with the exception of the south side. This area should be re-graded to provide better drainage away from the building. Also, trees and bushes on the left in the picture below should be removed to increase drainage and airflow around the building. This will help decrease moisture near the clapboards and trim.

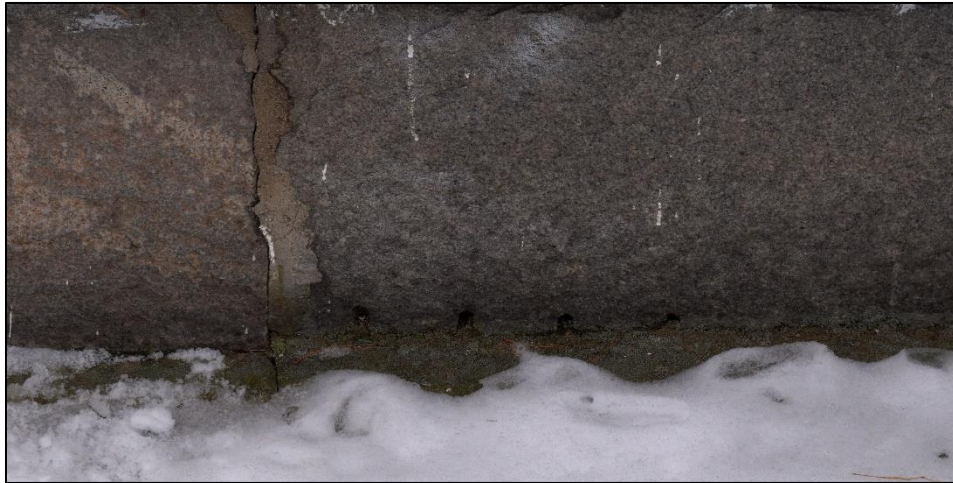
The foundation below grade is made of rubble stones which are then topped with finished granite blocks and appears to be in reasonable condition.

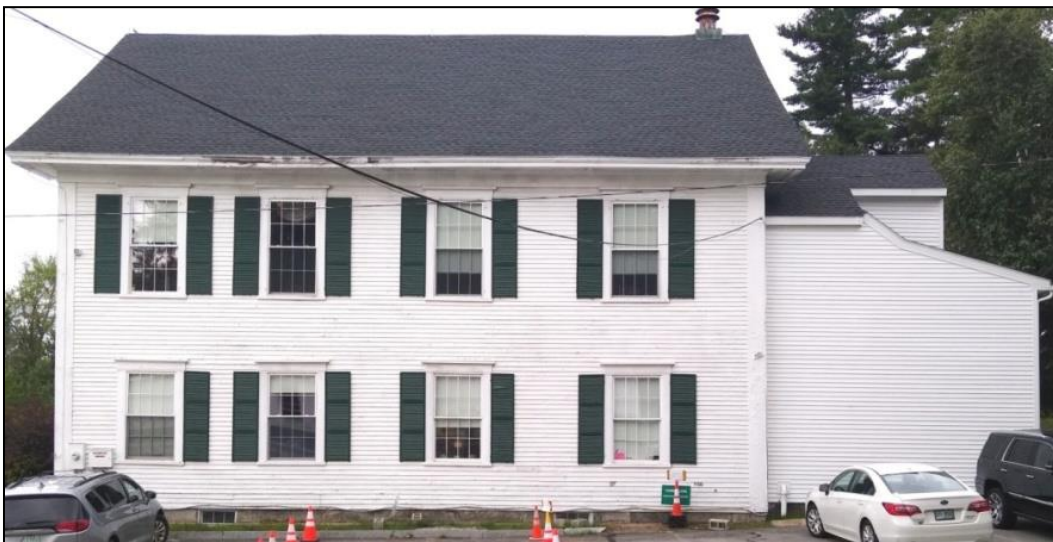
The roof covering is of asphalt and appears to be in good conditions. However, there are concerns about the area of a sag in the roof along the north eave side as there is a large amount of paint loss and discoloration. This would tend to indicate that there was or could be a leak in this area especially during the winter with ice dams. If only one row of ice and water shield was applied during the roofing process (from the eaves up to three feet) then ice will sometimes accumulate above that one row and cause water damage.

*North side looking south*

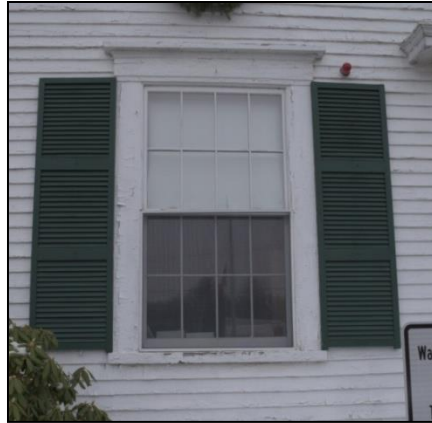
With the exception of the original but relocated arched window on the west gable end, the single pane window sashes were replaced in 1997 with thermo-paned wooden window sashes with snap on interior grills. The manufacturer's warrantee on these replacement windows expired many years ago and any repairs would only be temporary.

These 1997 windows are in fair condition with several having issues opening and closing appropriately.

*East side 1997 replacement sash, looking west  
(Photo by M. Williams)*

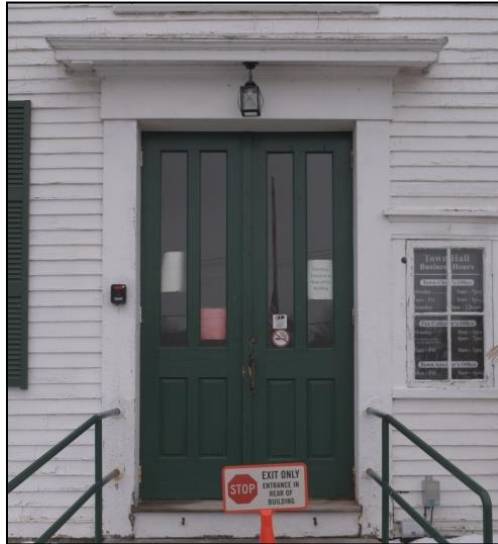
The front historic wooden double door is in reasonable condition, but is not ADA compliant because of the steps up to the threshold, the narrow width of each door, and the door knob. Fortunately, the rear exterior door is ADA compliant and it is understood that the rear entrance gets the most use. This rear door is a modern metal exterior door with ADA-compliant grab-bar handle.

*East double front door, looking west  
(Photo by M. Williams)*

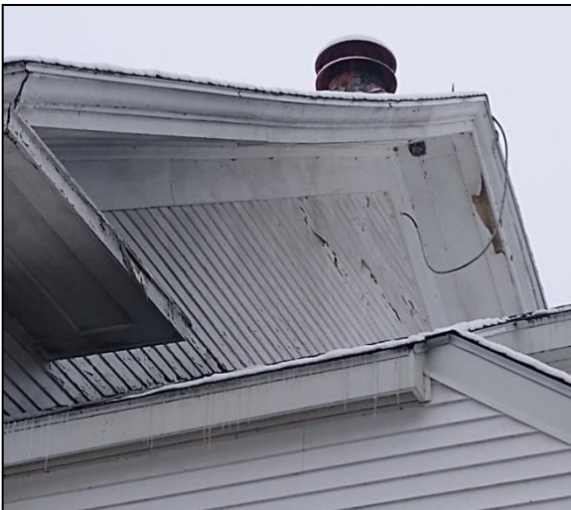
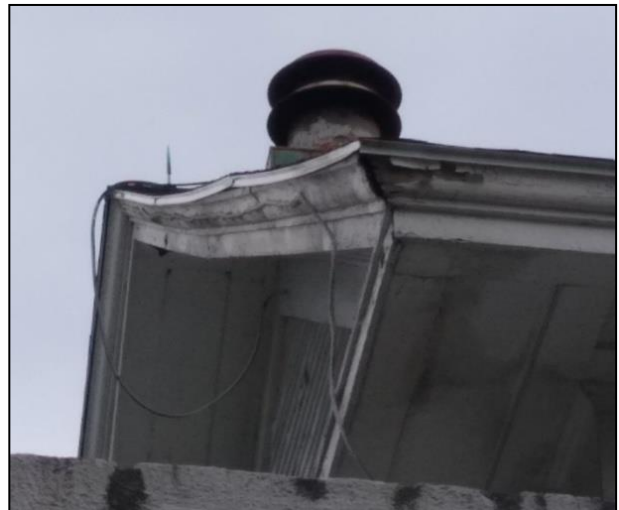
The trim along the extended gable-end overhangs on the west end are sagging considerably and need to be repaired, strengthened and straightened.

*Rake trim north side west gable end, facing south*

*Rake trim south side west gable end, facing north*

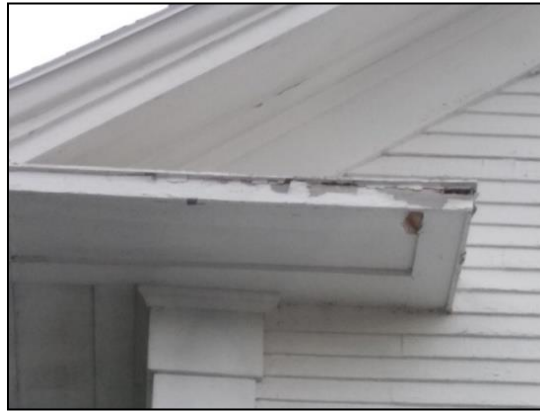
The gable end returns on the north and south side are also in need of repair/replacement as well as installing new flashing.

*East gable end returns looking west*

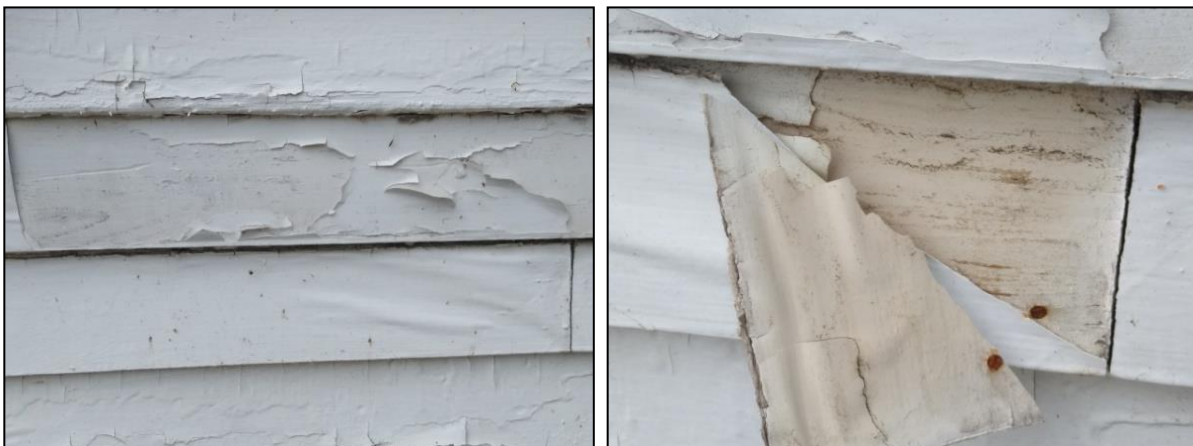
The paint is in fair condition and should be repainted as soon as possible. It would appear that there may be more than one problem causing the paint to peel. The first problem could be caused by incompatibility of the different paint surfaces and a second problem could be related to moisture getting in behind the clapboards and pushing its way out through the paint.

*North side peeling paint on clapboards*

Identifying the location of moisture can be difficult. The roof area and eave trim as well as potential moisture issues coming up from the crawl space into the exterior walls are definite possibilities.

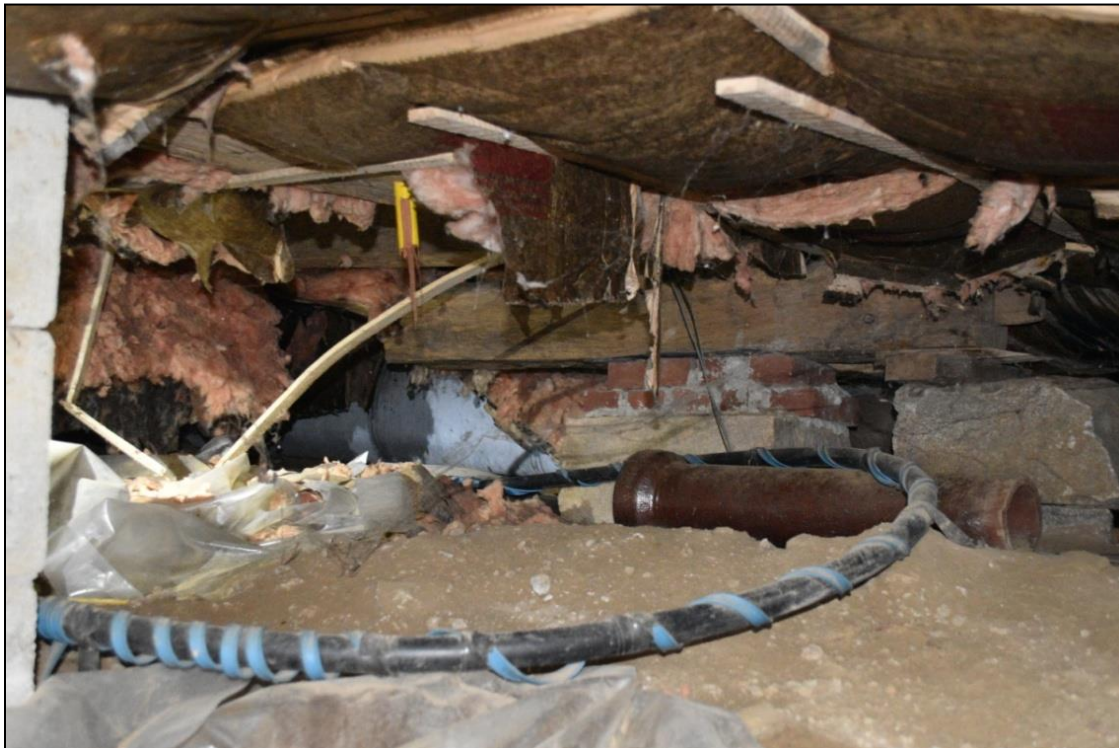
*Limited crawl space approximately halfway just inside south wall  
(Photo by M. Williams)*

Once the debris is all removed, then a proper assessment of the internal support piers and the joists can be accomplished.

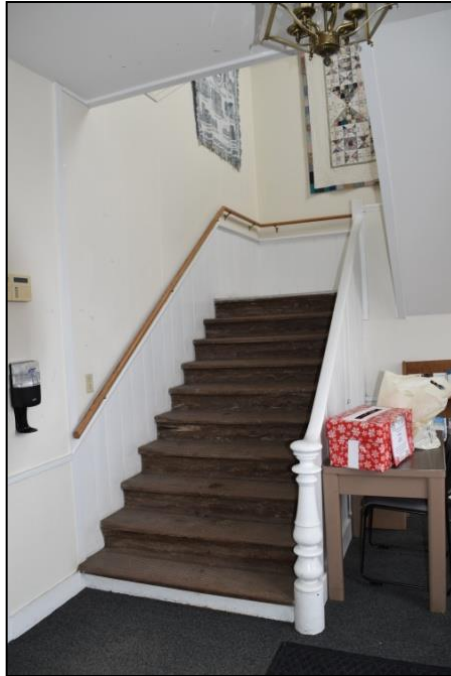
To the right of the first floor front entrance, there is the stairway that goes to the second floor meeting space. While an additional railing has been added to make the stairs safer, the original stairway railing does not meet current code requirements.

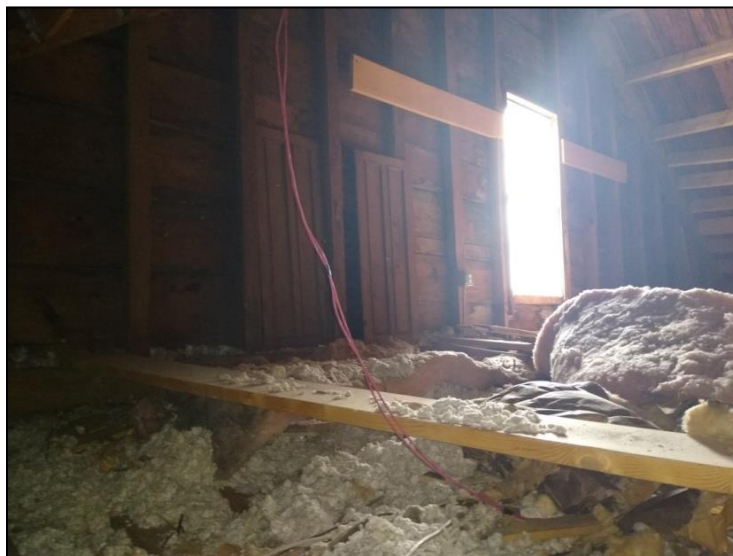
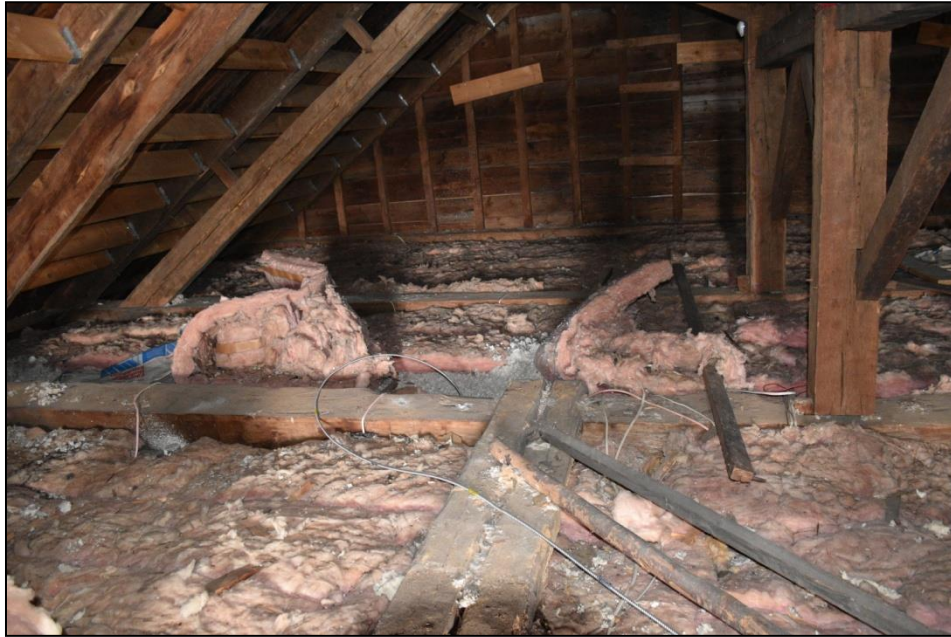
The attic of Town Hall is not usable and was insulated several years ago. Over the years, insulation has been moved around to gain access to wiring and rodents have also nested in the fiberglass insulation.

*Old, disturbed attic insulation, looking east*

*Old, disturbed attic insulation, looking west  
(Photo by M. Williams)*

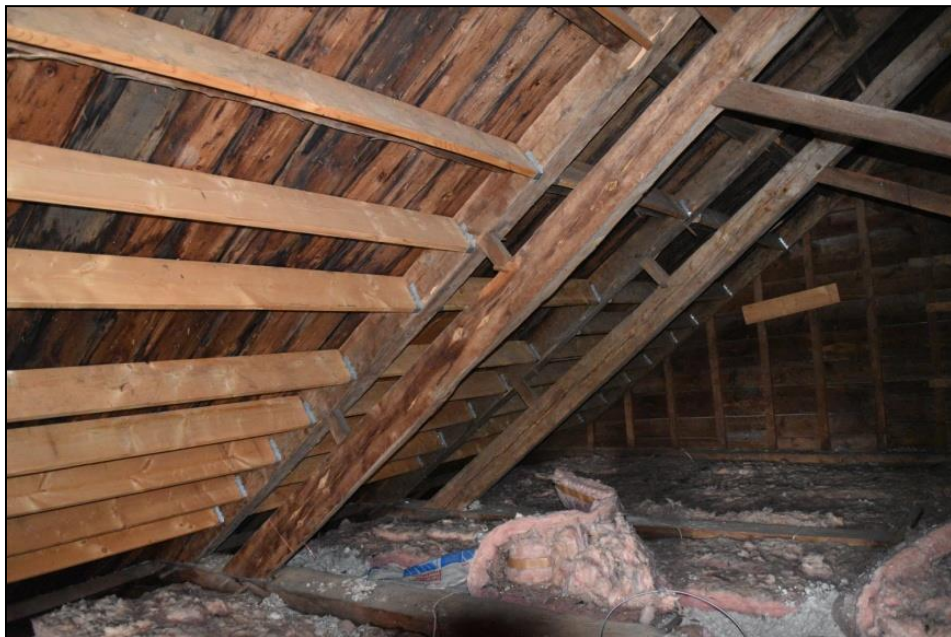
The roof framing has been repaired and strengthened over the years. Original purlins have been added on to or replaced in the roof structure to help with the natural occurring deflection in the purlins between the rafters. In the photograph below, additional 2 x 8 purlins have been added to the existing purlins as well as being added between purlins. These new purlins are held in place and connected to the rafters by metal joist hangers.

*South easterly roof structure, looking south westerly  
(Photo by M. Williams)*
