Structural Assessment Report

Town of Windham

44 Partridge Road
Windham, NH

RE: Windham Town Hall
Structural Condition Assessment

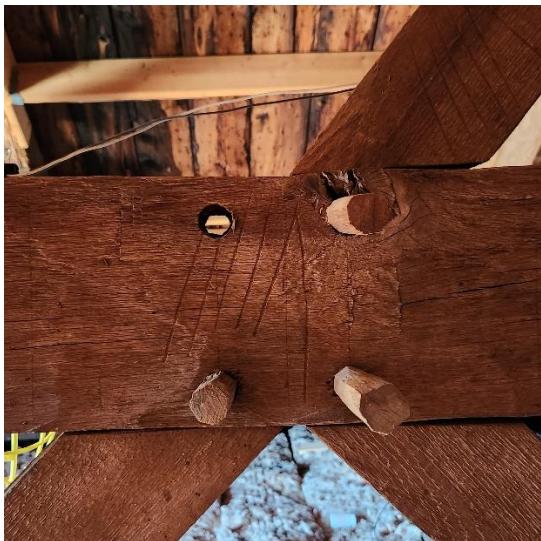
Photo 10: Traditional hole and peg construction of the diagonal bracing.
Missing Brace and peg

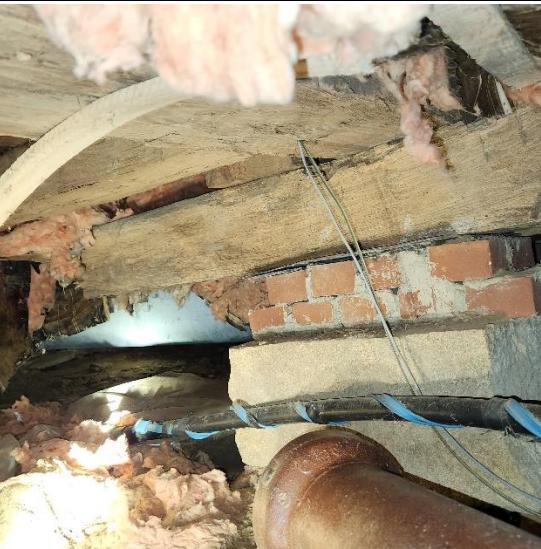
Photo 14: Foundation support of various materials supporting a first-floor beam

The foundation and crawl space area beneath the building should be completely redone. It is recommended that the gravel floor be excavated to a depth of approximately 3 feet and a 2-inch "rat slab" installed. This slab would allow for a more accessible crawl space beneath the building as well as serve as a barrier against water or animal intrusion. After excavation is completed, the interior support foundations should be jacked up, removed, and replaced with the appropriate kind of footings.

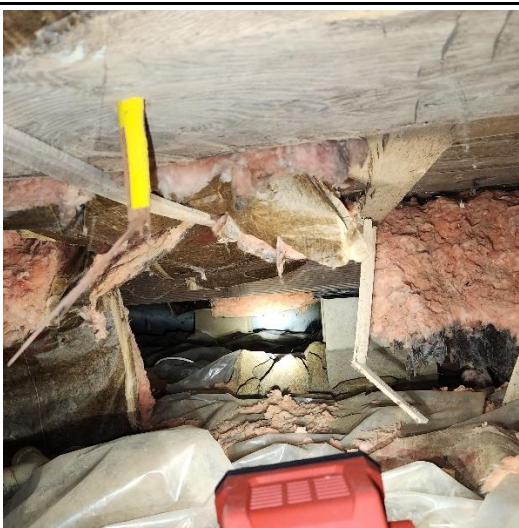
Photo 15: Failing insulation between first-floor floor joists

The first-floor insulation located between the floor joists should be removed and replaced. This would be best accomplished during the recommended repairs for the foundation. See below.

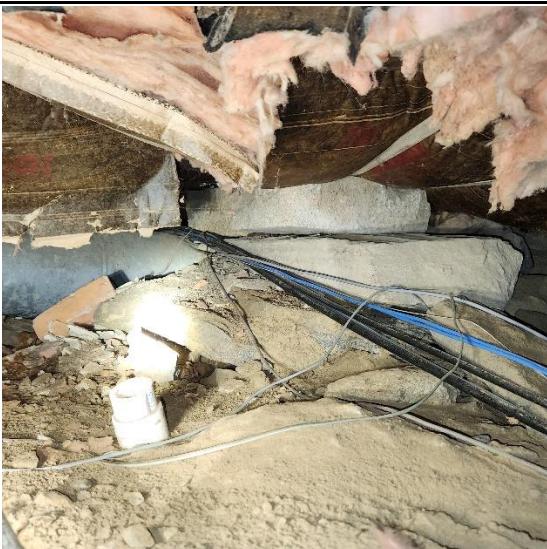
Photo 16: Stacked granite supporting a first-floor beam

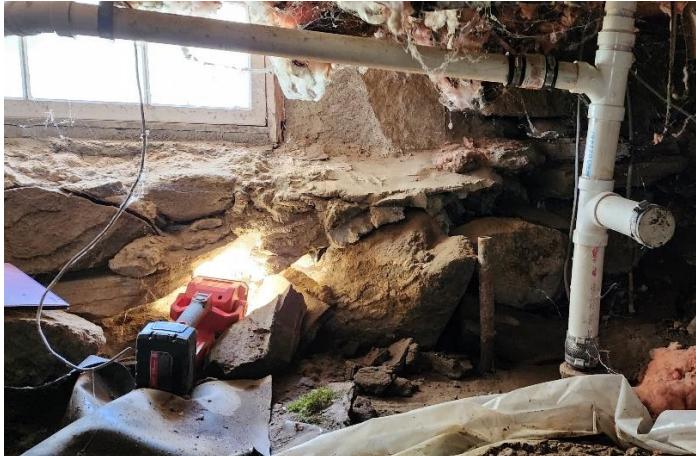
Photo 20: Stacked stone foundation under granite block

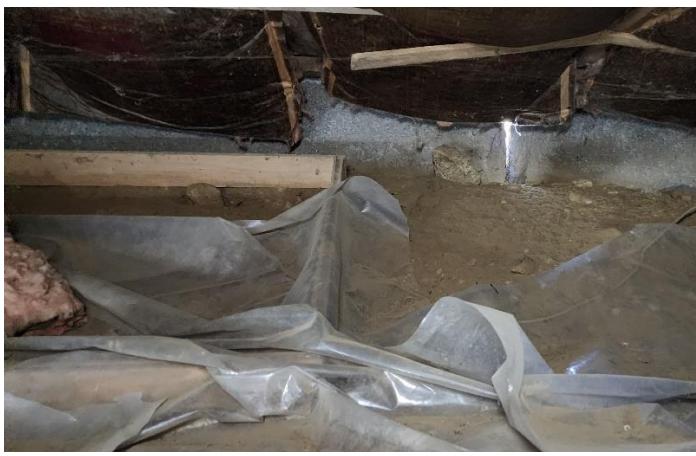
Photo 21: Openings between granite block foundation

Any areas of the exterior granite foundation that appear to need repointing should be addressed while this work is being done.

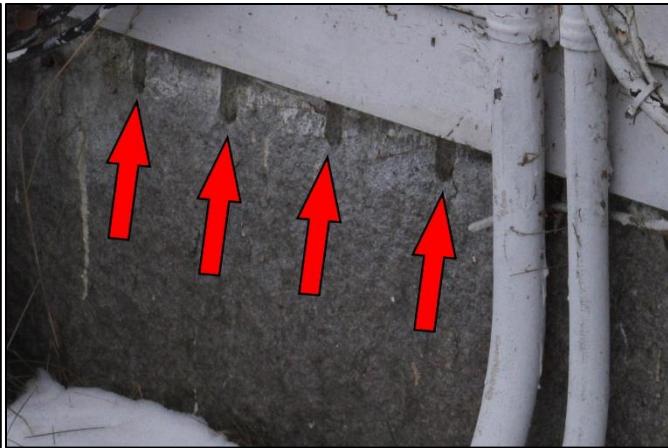
Figure 10: Plug and feather marks in granite underpinning

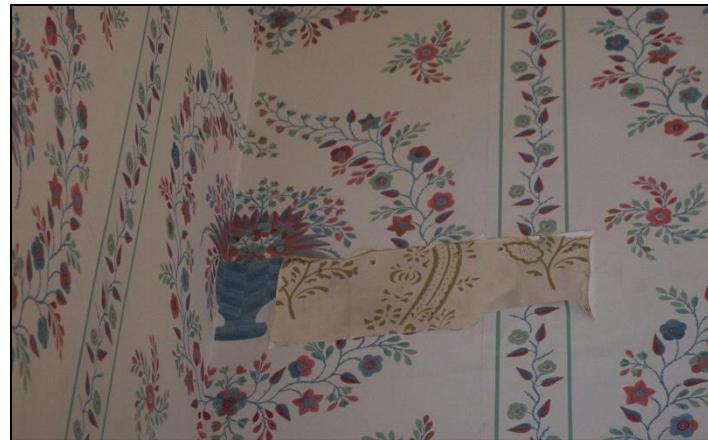
Figure 27: Tear in late 20th century wallpaper revealing ca. 1954 pattern

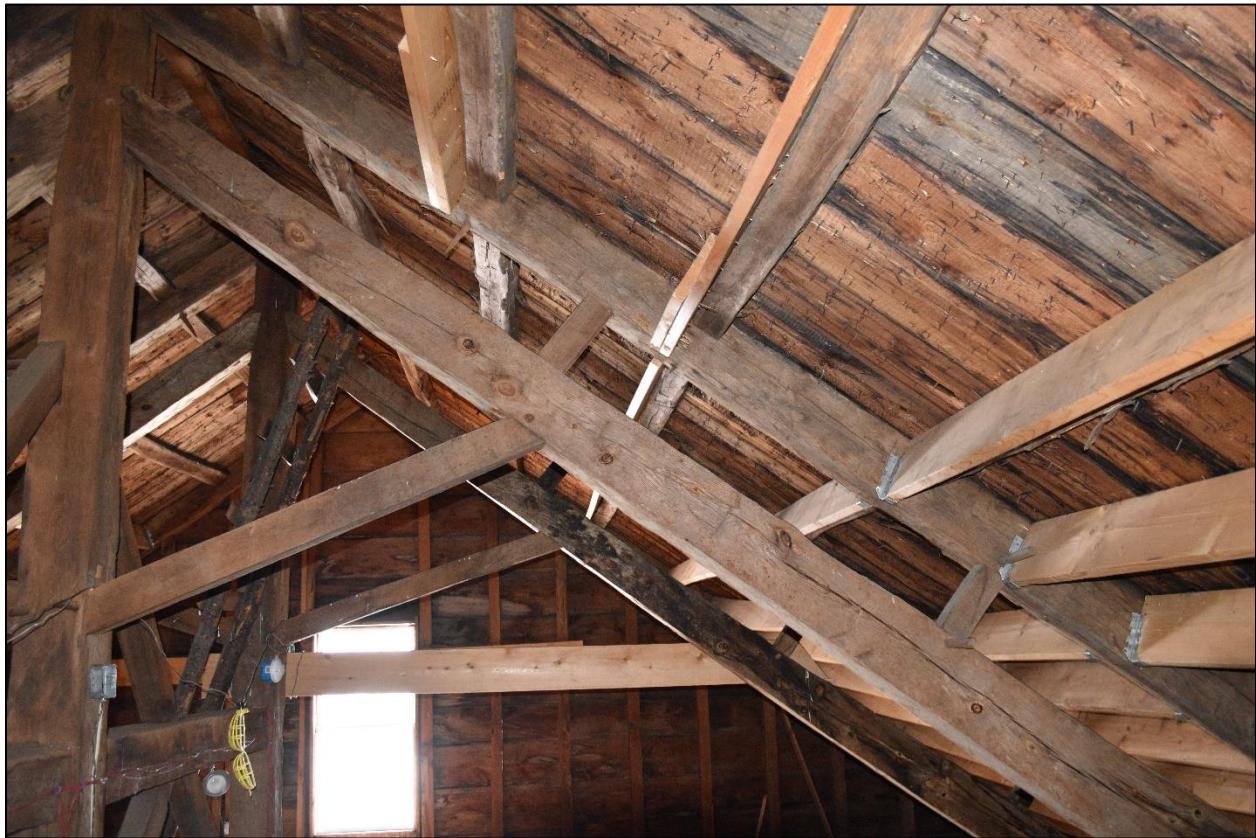
Throughout the 20th century, additional modern lumber was added to the historic frame in an effort to provide additional strength (figure 35). The modern framing elements are all modern dimensional lumber set on modern metal hangers and laid next to the historic frame. The modern additions are done in such a way as to be clearly differentiated from the historic frame and reversible, thus complying with the *Secretary of the Interior's Standards*.

Figure 35: View of attic, facing east, showing modern framing that has been added to the historic frame

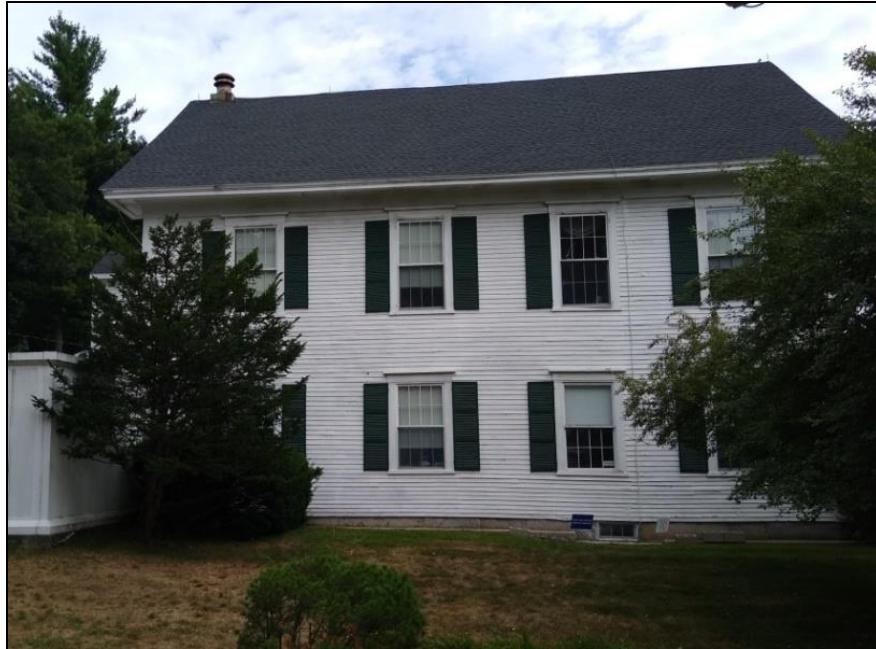
South elevation, facing north

The site conditions around the Town Hall provide good drainage with the exception of the south side. This area should be re-graded to provide better drainage away from the building. Also, trees and bushes on the left in the picture below should be removed to increase drainage and airflow around the building. This will help decrease moisture near the clapboards and trim.

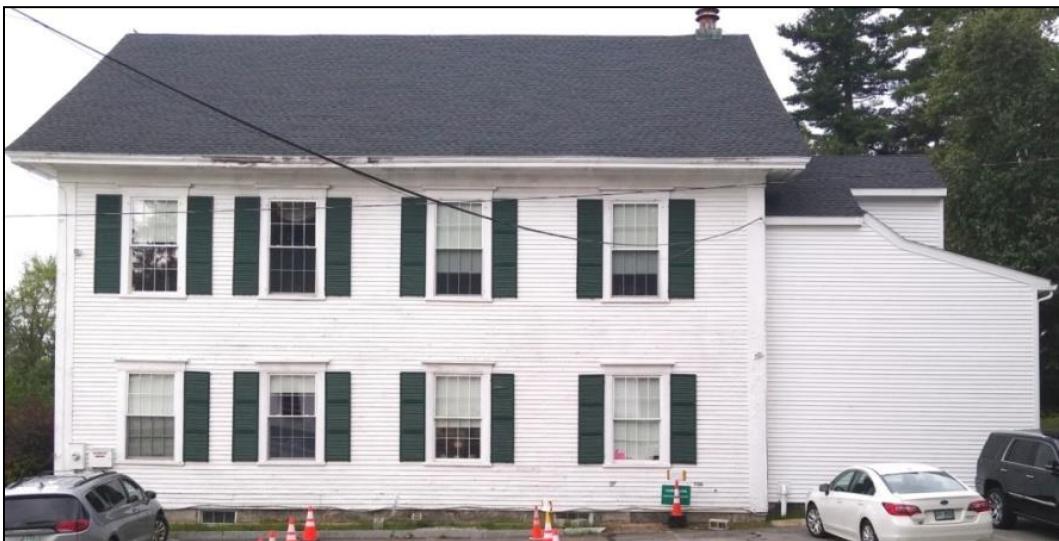
North side looking south

The roof covering is of asphalt and appears to be in good conditions. However, there are concerns about the area of a sag in the roof along the north eave side as there is a large amount of paint loss and discoloration. This would tend to indicate that there was or could be a leak in this area especially during the winter with ice dams. If only one row of ice and water shield was applied during the roofing process (from the eaves up to three feet) then ice will sometimes accumulate above that one row and cause water damage.

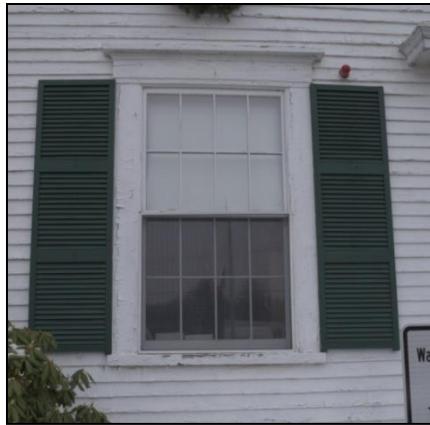
These 1997 windows are in fair condition with several having issues opening and closing appropriately.

*East side 1997 replacement sash, looking west
(Photo by M. Williams)*

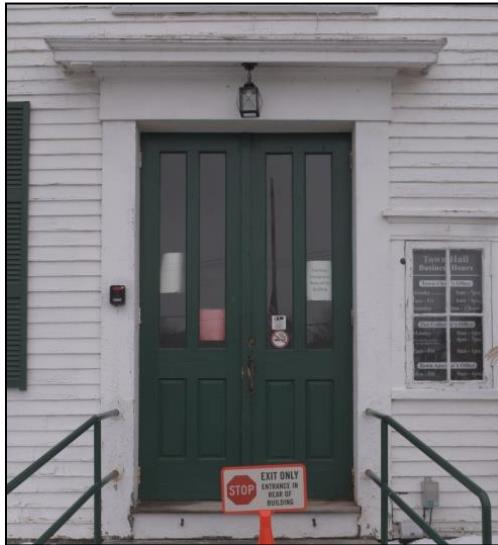
The front historic wooden double door is in reasonable condition, but is not ADA compliant because of the steps up to the threshold, the narrow width of each door, and the door knob. Fortunately, the rear exterior door is ADA compliant and it is understood that the rear entrance gets the most use. This rear door is a modern metal exterior door with ADA-compliant grab-bar handle.

*East double front door, looking west
(Photo by M. Williams)*

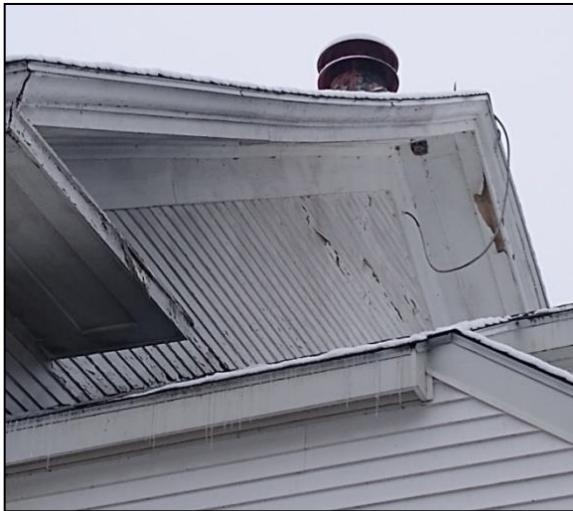
The trim along the extended gable-end overhangs on the west end are sagging considerably and need to be repaired, strengthened and straightened.

Rake trim north side west gable end, facing south

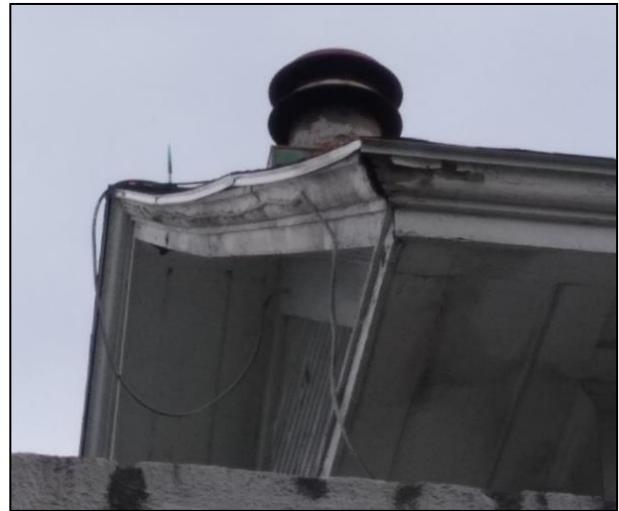
Rake trim south side west gable end, facing north

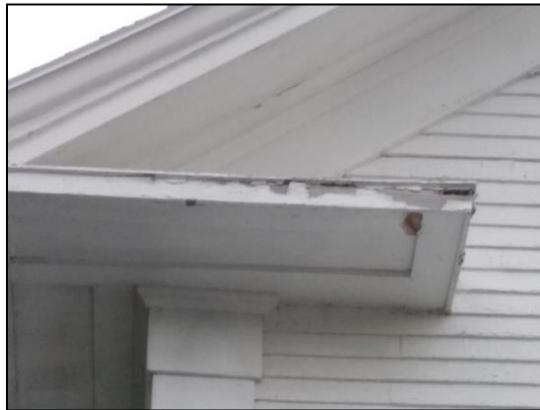
The gable end returns on the north and south side are also in need of repair/replacement as well as installing new flashing.

East gable end returns looking west

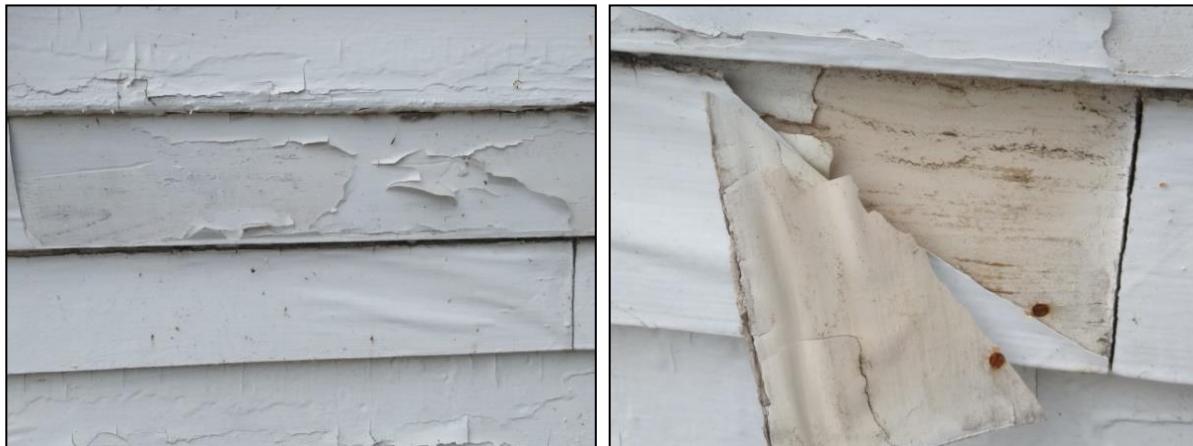
The paint is in fair condition and should be repainted as soon as possible. It would appear that there may be more than one problem causing the paint to peel. The first problem could be caused by incompatibility of the different paint surfaces and a second problem could be related to moisture getting in behind the clapboards and pushing its way out through the paint.

North side peeling paint on clapboards

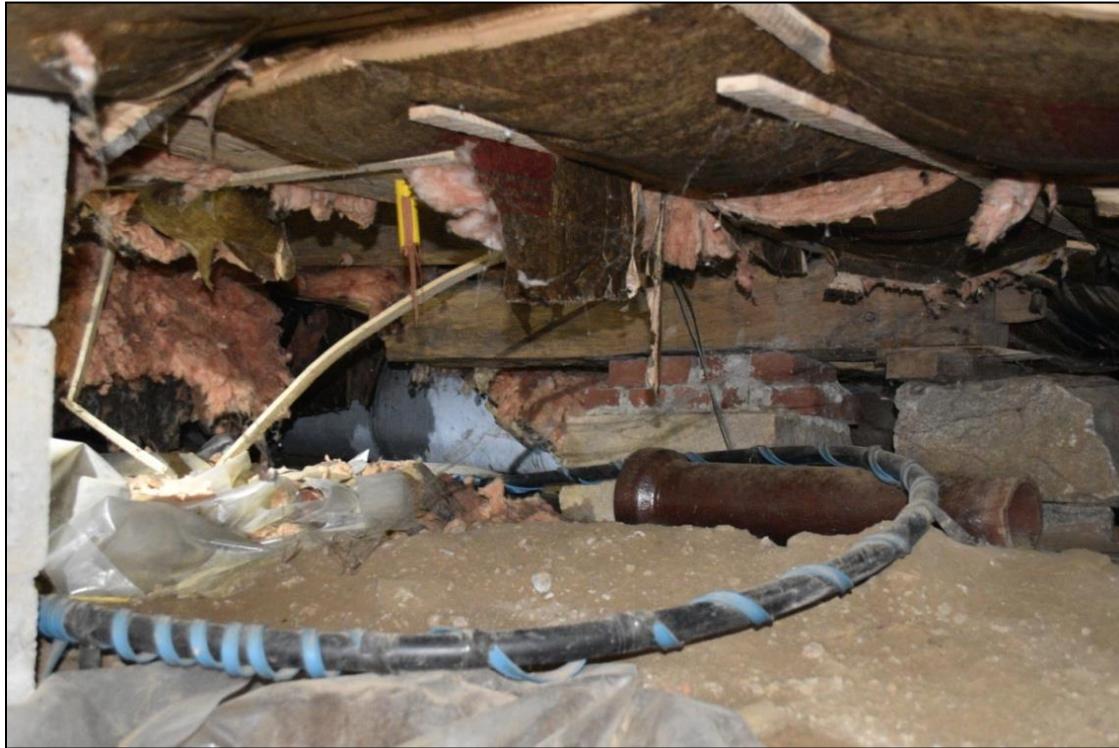
*Limited crawl space approximately halfway just inside south wall
(Photo by M. Williams)*

Once the debris is all removed, then a proper assessment of the internal support piers and the joists can be accomplished.

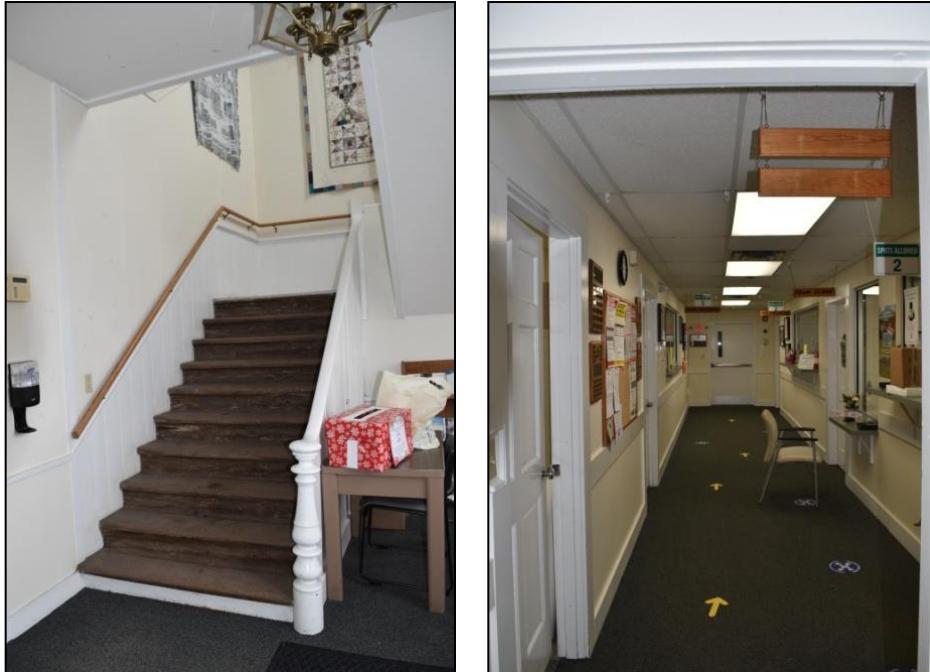
To the right of the first floor front entrance, there is the stairway that goes to the second floor meeting space. While an additional railing has been added to make the stairs safer, the original stairway railing does not meet current code requirements.

*First floor stairway to second floor, looking north First floor hallway, looking east
(Photos by M. Williams)*

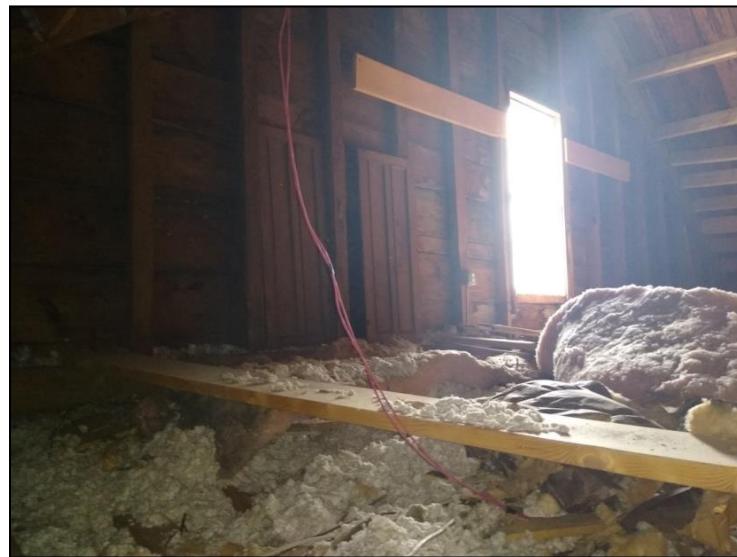
Old, disturbed attic insulation, looking east

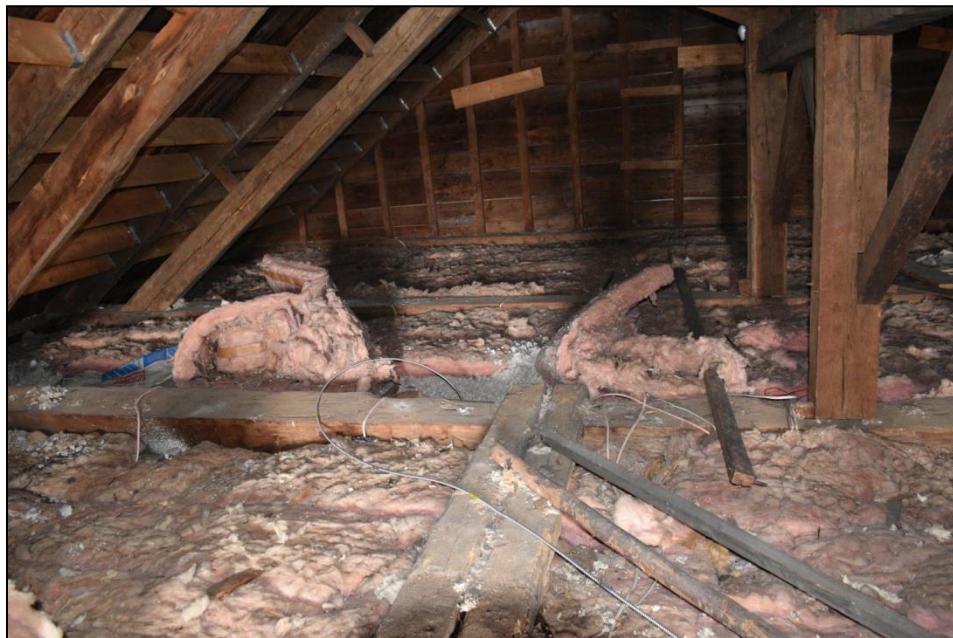
*Old, disturbed attic insulation, looking west
(Photo by M. Williams)*
