# Windham Town Hall

## Condition Assessment Report for the Town of Windham

Final January 31, 2022

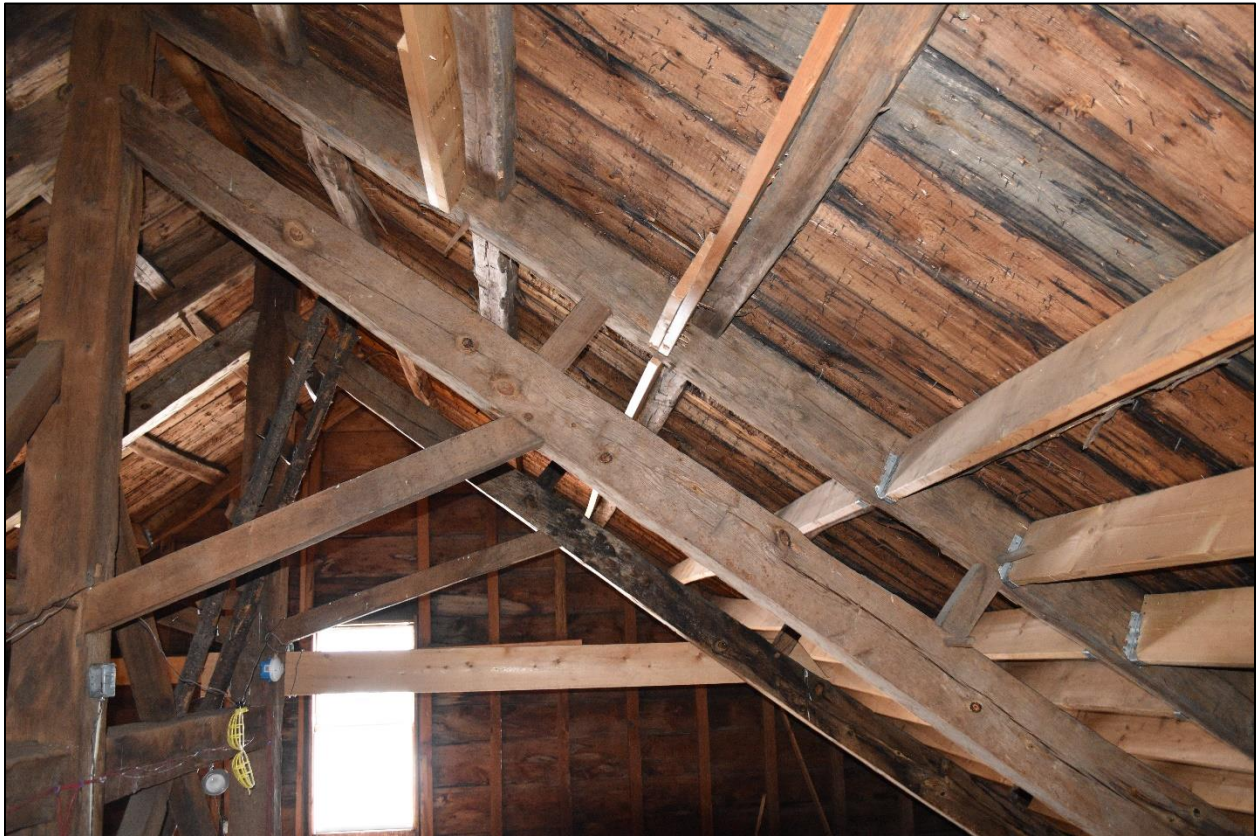
Throughout the 20<sup>th</sup> century, additional modern lumber was added to the historic frame in an effort to provide additional strength (figure 35). The modern framing elements are all modern dimensional lumber set on modern metal hangers and laid next to the historic frame. The modern additions are done in such a way as to be clearly differentiated from the historic frame and reversible, thus complying with the *Secretary of the Interior's Standards*.

Figure 35: View of attic, facing east, showing modern framing that has been added to the historic frame

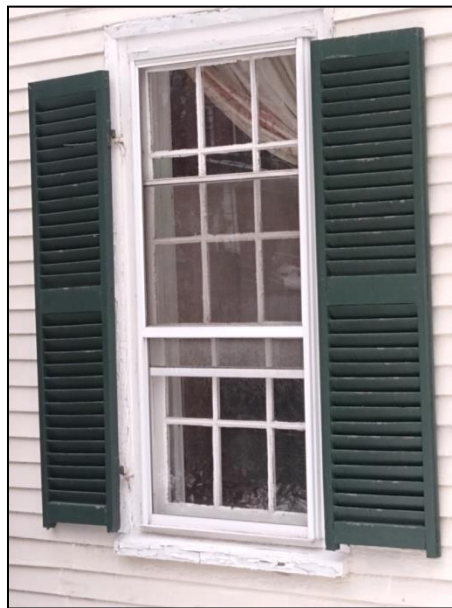
The blinds are in reasonable condition, are hung outside of their original location and hung backwards on the building. Traditionally, when the blinds are closed they shed water away from the building. When open against the building, the louvers will shed water towards the building as in the photo below.

*Appropriate hung blinds in the open position  
House in Newfields, NH*

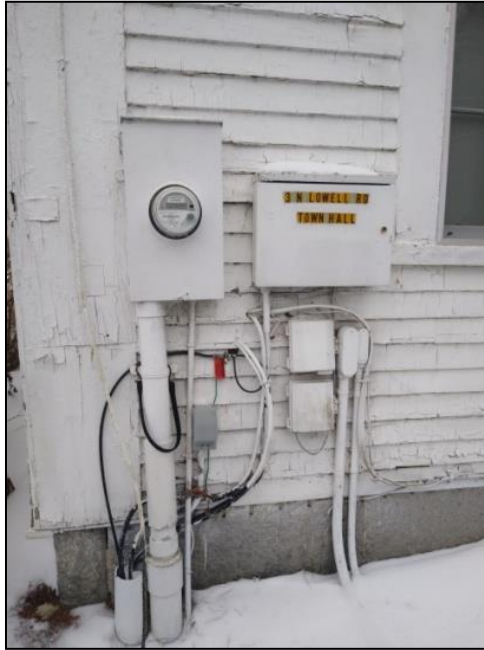
It appeared on my two visits that the mechanical systems were in working order. The current electrical system is 200-amp or greater, and the building wiring was updated in ca. 1990 as part of the building renovation. No deficiencies have been reported by local officials.

*Electrical and Communication services located on the north side*
