Structural Assessment Report

Town of Windham

44 Partridge Road
Windham, NH

RE: Windham Town Hall
Structural Condition Assessment

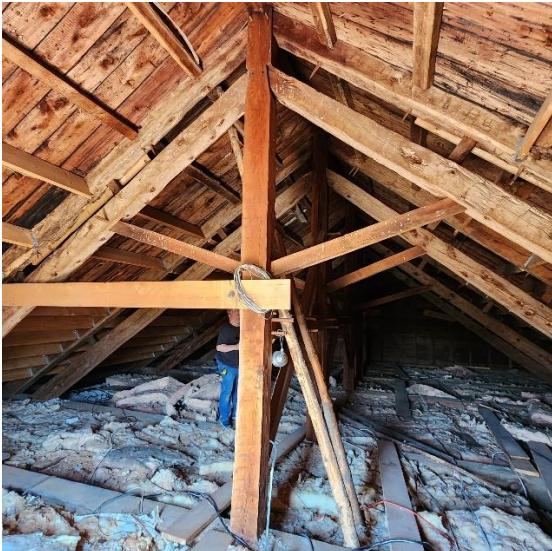
The attic supporting members were in good condition. Beams and posts were checked for rot, but no instances of structural impairment were found. Existing roof joists were sistered with 2x10's and joist hangers @ 17-inches OC for approximately half the height of the roof.

Photo 2: Post and beam supporting members in the attic

It is recommended that a catwalk be installed between the timber framing members so access to the attic space is safe and inspections/repairs can be performed.

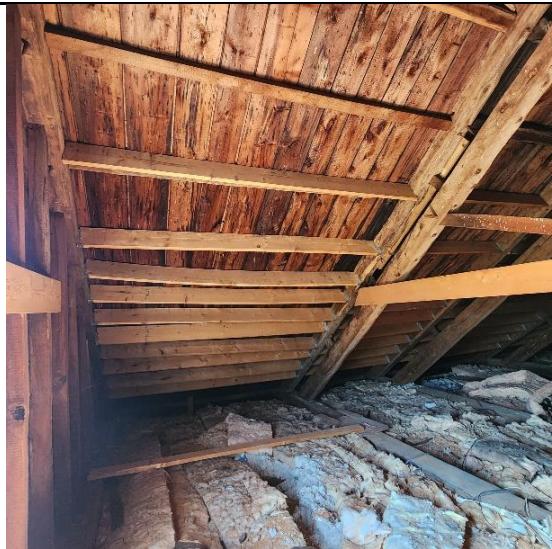
Photo 3: Sistered 2x10 roof joists in lower half's

The 2x10's that currently sister the original roof joists should be continued at the same spacing for the remaining height of the roof. Any 2x10's that have exhibited twisting or splitting should be removed and replaced. Proper fasteners such as joist hangers should be used whenever possible.

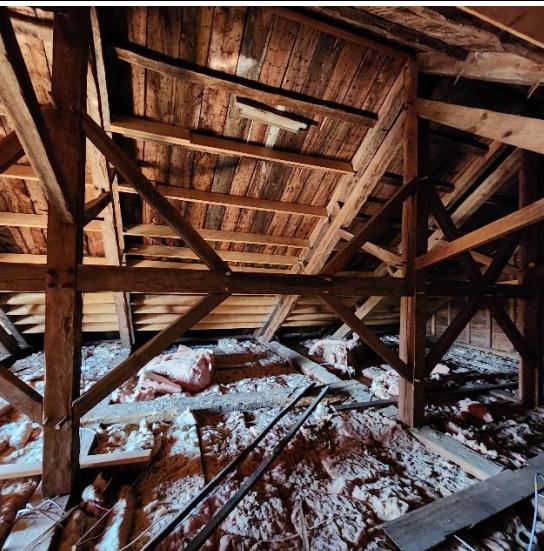
Photo 5: Intermediate diagonal bracing between roof supporting posts

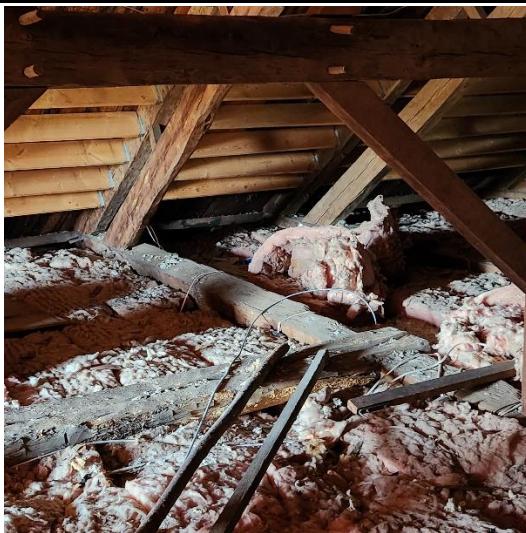
Beams running north-south along the floor of the attic support the posts and beams that support the roof. As viewed from the front of the Town Hall, the third primary supporting floor beam displayed severe twist over its entire length. This twist was likely caused by the roof load being transferred to the floor beam from the roof beam that sits slightly off center on the floor beam. Despite the twist, the beam seems to remain structurally sound.

Photo 6: Severely twisted attic floor beam as viewed from the side

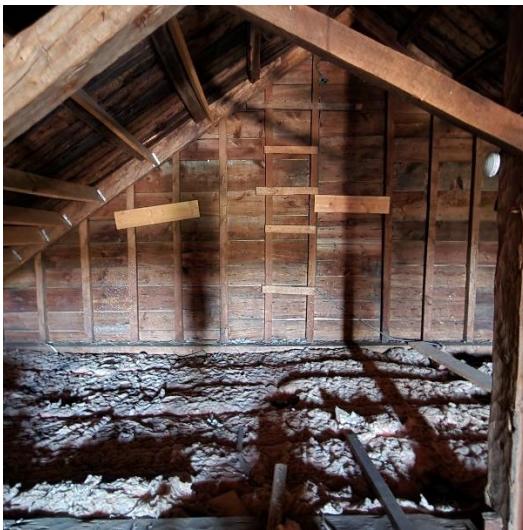
Photo 9: View of the far gable end wall in the attic

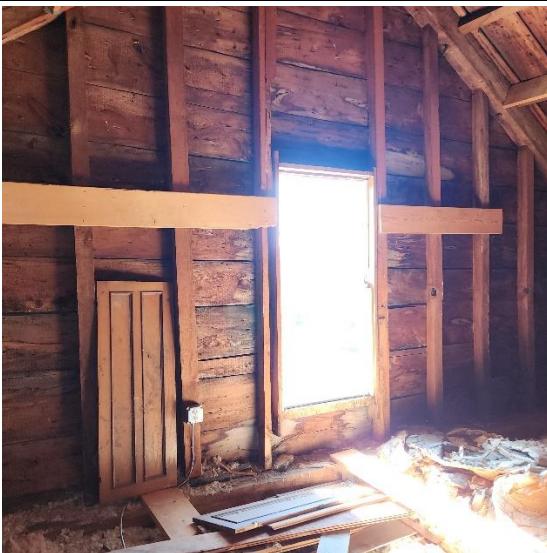
Photo 11: Entry gable end wall and window of the Town Hall

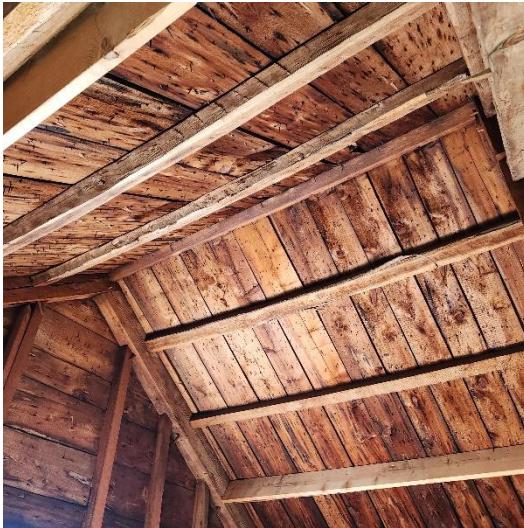
Photo 12: Upper section of the roof without the sistered 2x10's

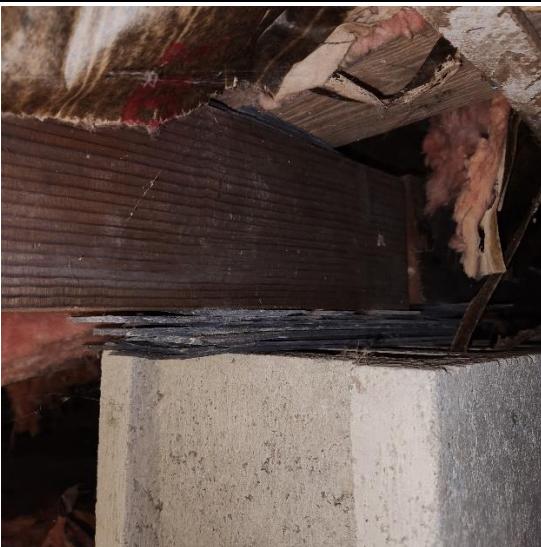
Photo 13: Plastic shims on cinderblocks supporting a first-floor beam

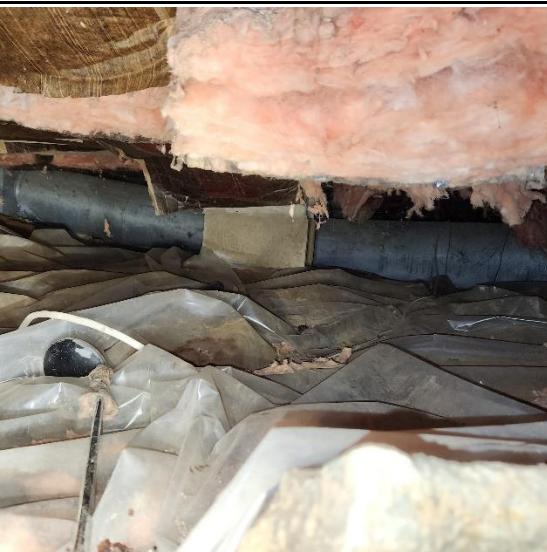
Photo 17: Vent pipe that runs through the crawl space

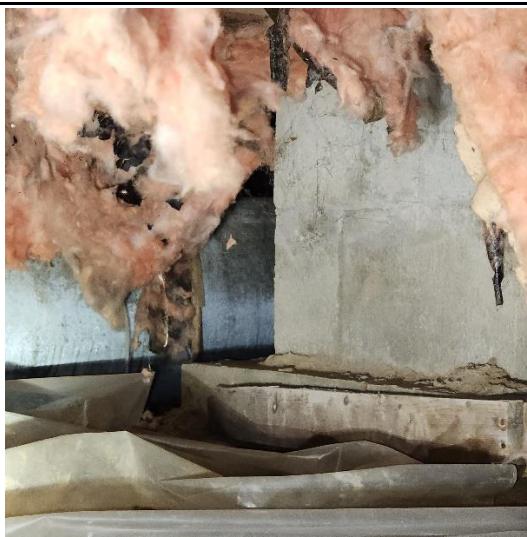
Photo 18: Apparent break in vent pipe

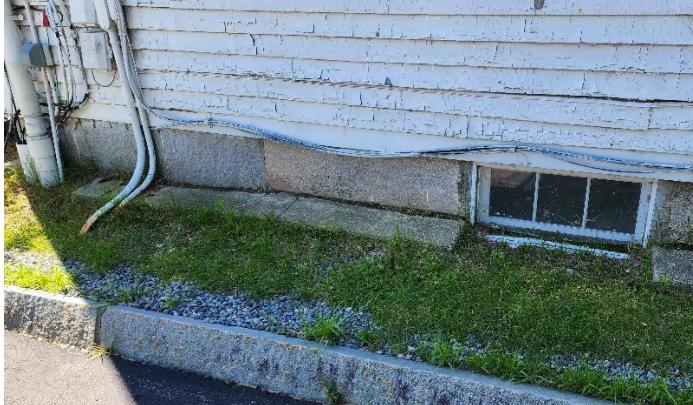
The crawl space allowed limited access to the foundation beneath the Town Hall. From what was able to be observed, the exterior granite foundation was in good condition but appeared not to be constructed below the frost line. The interior foundations that were observed were not adequately supported and considered to be in poor condition. The interior piers were constructed from multiple materials including wood, CMU block, stone and brick. Many of the piers are undermined and supported right at grade. There is no vapor barrier on the ground which exposes the framing and

Photo 22: Granite top block foundation from exterior

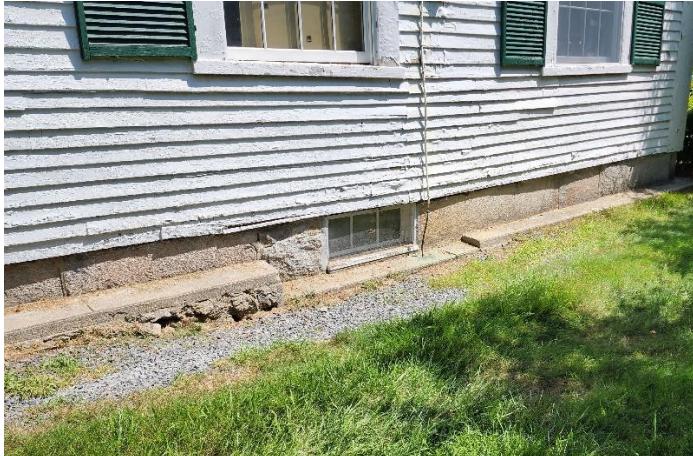
Photo 23: Granite block foundation with concrete skirt

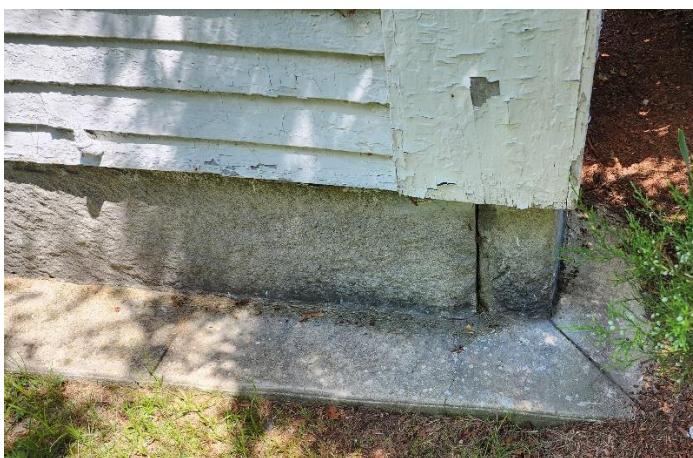
Photo 24: Granite block foundation with concrete skirt

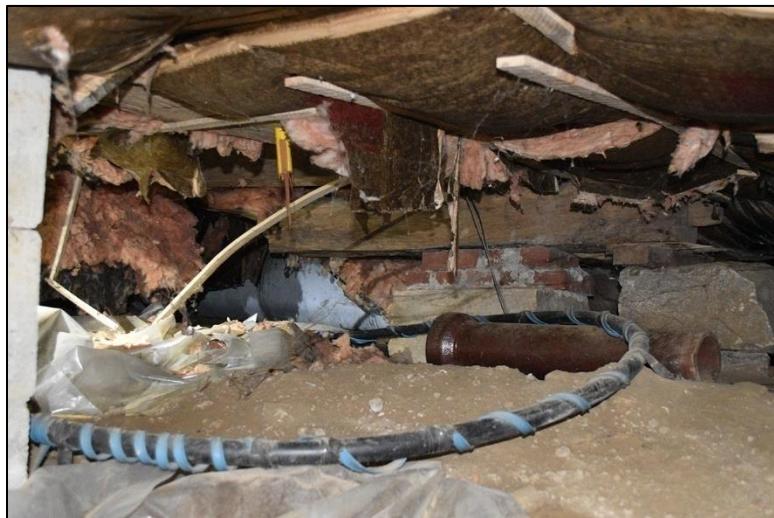
Figure 18: Crawl-space beneath Town Hall

There is an extremely small and cramped crawl-space beneath the Town Hall, which is accessible through a floor hatch in the office adjacent to the first-floor kitchenette. The area directly beneath the hatch has been slightly excavated, to allow about 2.5 to 3 feet of head-room (figure 18). The earthen floor is very uneven, and curves up away from this area, so that there is only about 2 feet of space between the sandy soil and first-floor frame. Intermediate cinderblock and/or brick piers interrupt the area (there is also at least one stone pier), providing additional support to the first-floor. Many of the piers were added in the 1950s as part of a foundation-repair project. There are three-light basement windows at each corner of the building that were also added at this time (figure 6). Sections of the dirt floor are covered with thick plastic. Insulation batts were added to the underside of the first-floor framing and affixed with narrow battens. Low-hanging metal duct-work from an historic heating system (no longer in operation) prevented the full exploration of this area during the site visit.

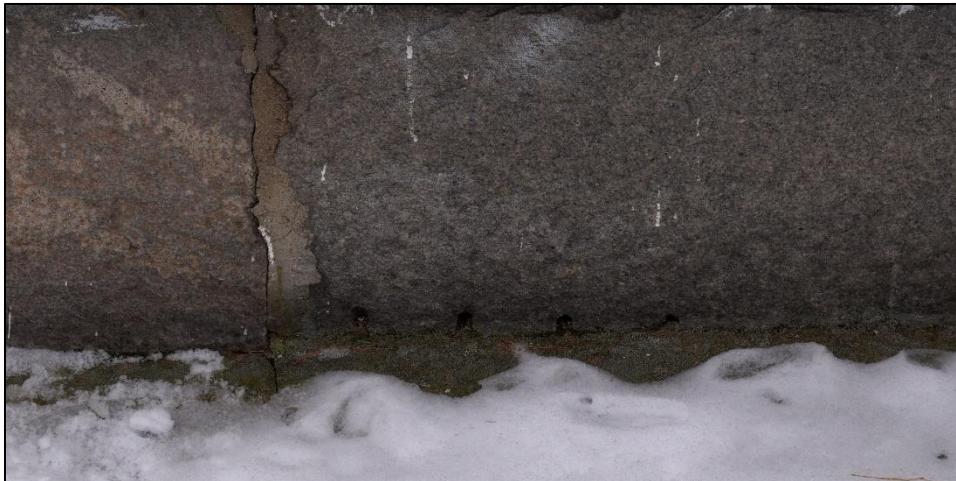
The foundation below grade is made of rubble stones which are then topped with finished granite blocks and appears to be in reasonable condition.

North side, looking south (Photo by M. Williams)

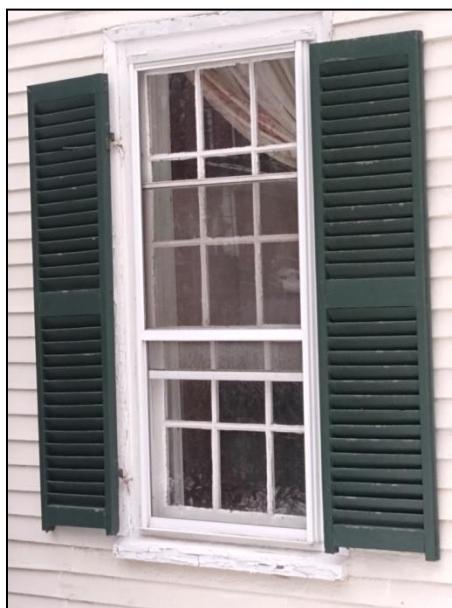
The blinds are in reasonable condition, are hung outside of their original location and hung backwards on the building. Traditionally, when the blinds are closed they shed water away from the building. When open against the building, the louvers will shed water towards the building as in the photo below.

*Appropriate hung blinds in the open position
House in Newfields, NH*

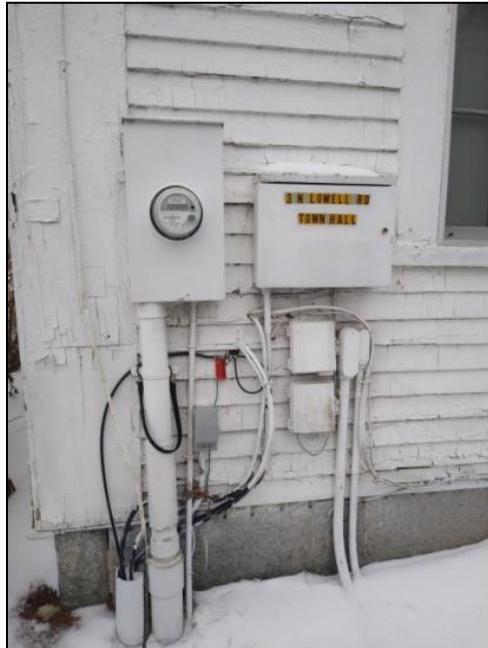
It appeared on my two visits that the mechanical systems were in working order. The current electrical system is 200-amp or greater, and the building wiring was updated in ca. 1990 as part of the building renovation. No deficiencies have been reported by local officials.

Electrical and Communication services located on the north side

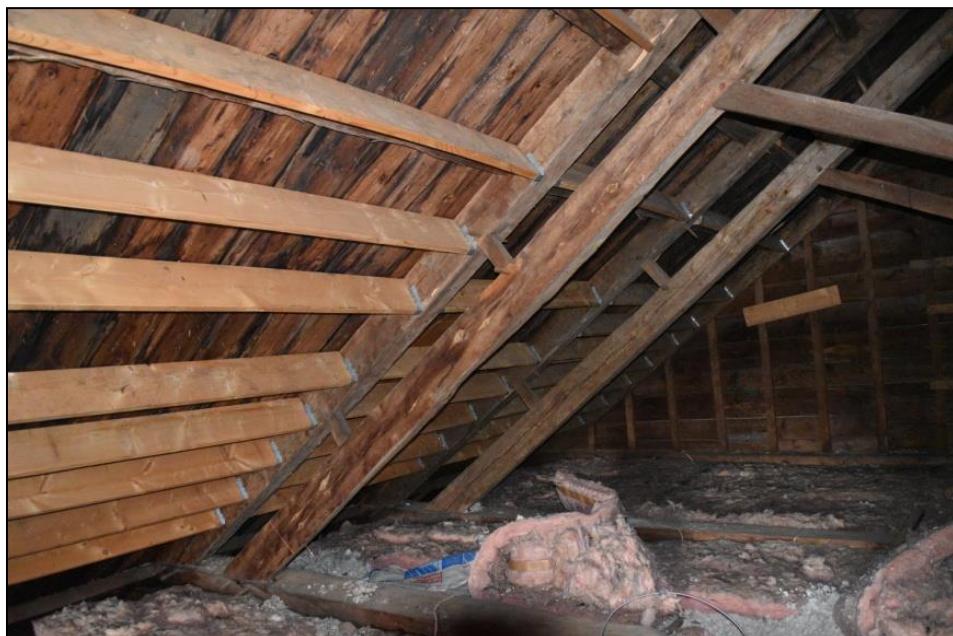
The roof framing has been repaired and strengthened over the years. Original purlins have been added on to or replaced in the roof structure to help with the natural occurring deflection in the purlins between the rafters. In the photograph below, additional 2 x 8 purlins have been added to the existing purlins as well have being added between purlins. These new purlins are held in place and connected to the rafters by metal joist hangers.

*South easterly roof structure, looking south westerly
(Photo by M. Williams)*
